Fire, Water and Load Tests on  
Berger's *Metal Lumber* System  
(Patented)

Pressed Steel Fireproof Construction

## Test No. 1. (Unofficial)

## Test No. 2. (Official)

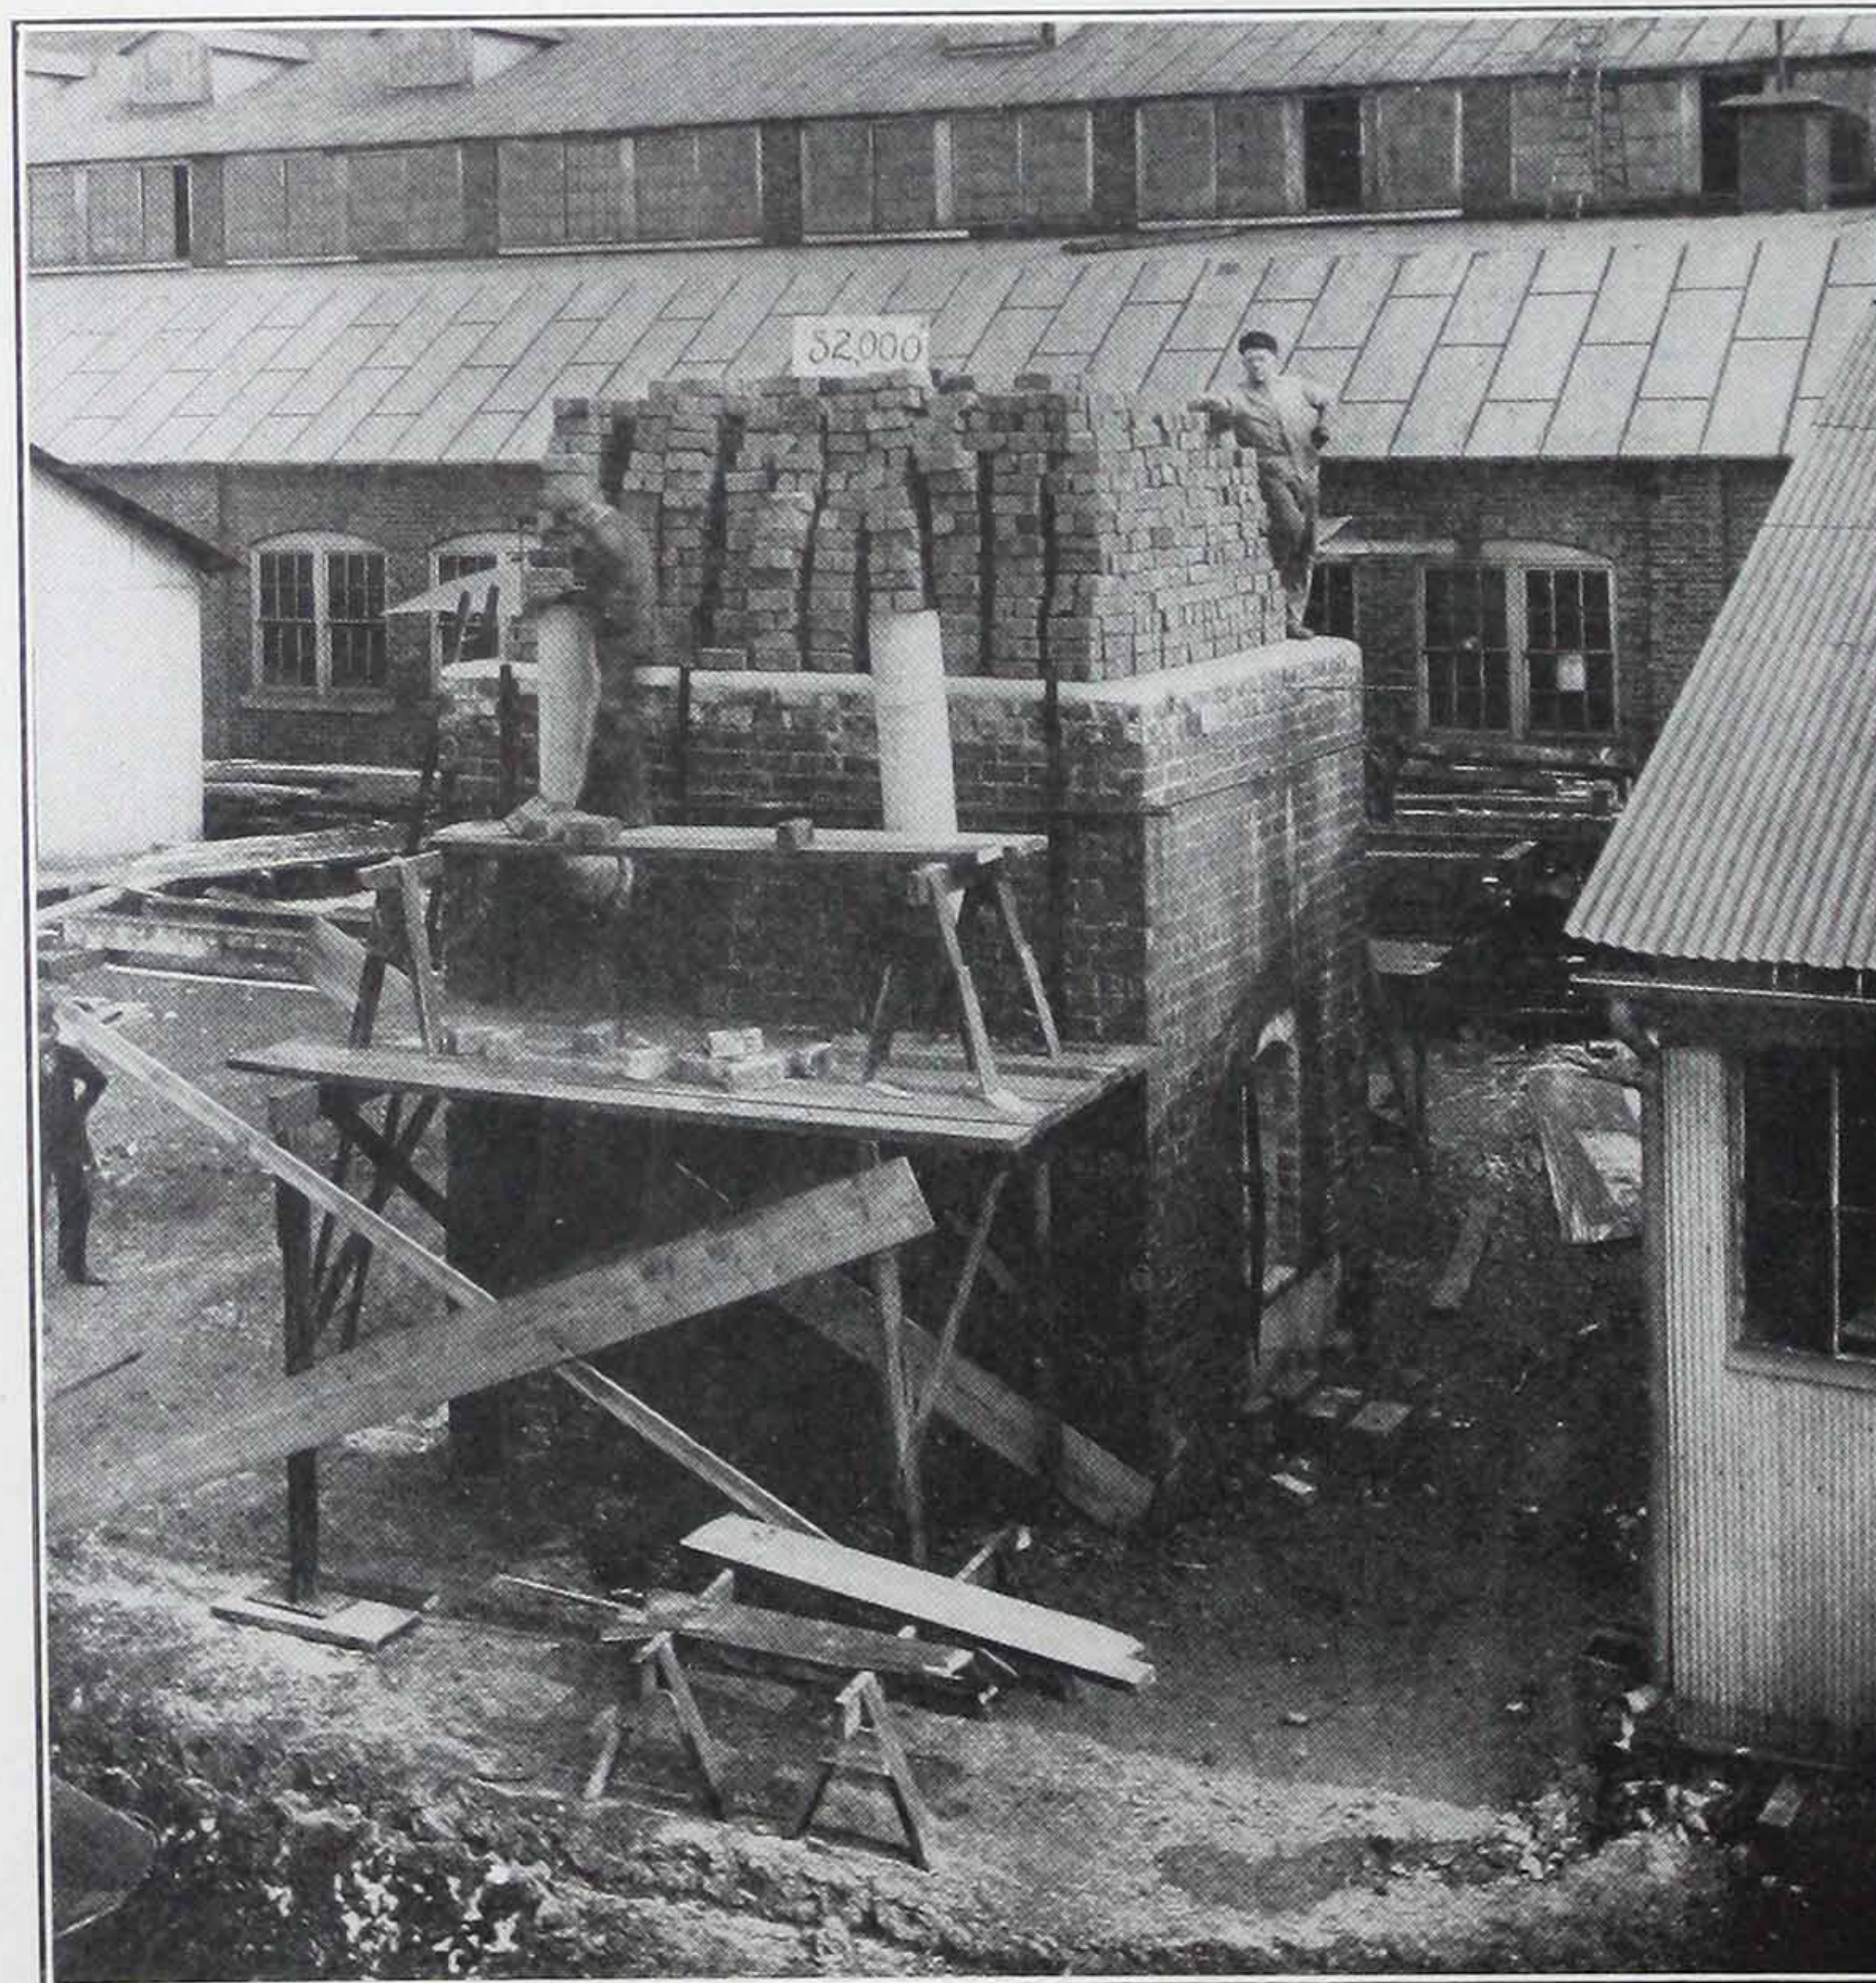
The effect of this fire, load and water test upon the Metal Lumber floor construction was highly satisfactory; the resistance of the material to the combined test can be considered remarkable in view of existing conditions. This material was tested with no more than 5/16 of an inch of cement plaster applied on the Expanded Metal Lath throughout three-fourths of the area of the ceiling. For material to be subjected to a

temperature of more than 1700 degrees Fahrenheit under a load of 135 pounds per square foot, dead and live, with only 5/16 of an inch protection, proves conclusively the merits of the dead air space insulation and the resistance of Berger's special analysis Pressed Steel sections to intense heat. No fire, water or smoke came through the roof (or floor) construction.

Load Test Made Feb. 25th After Fire and Water Tests were Executed.

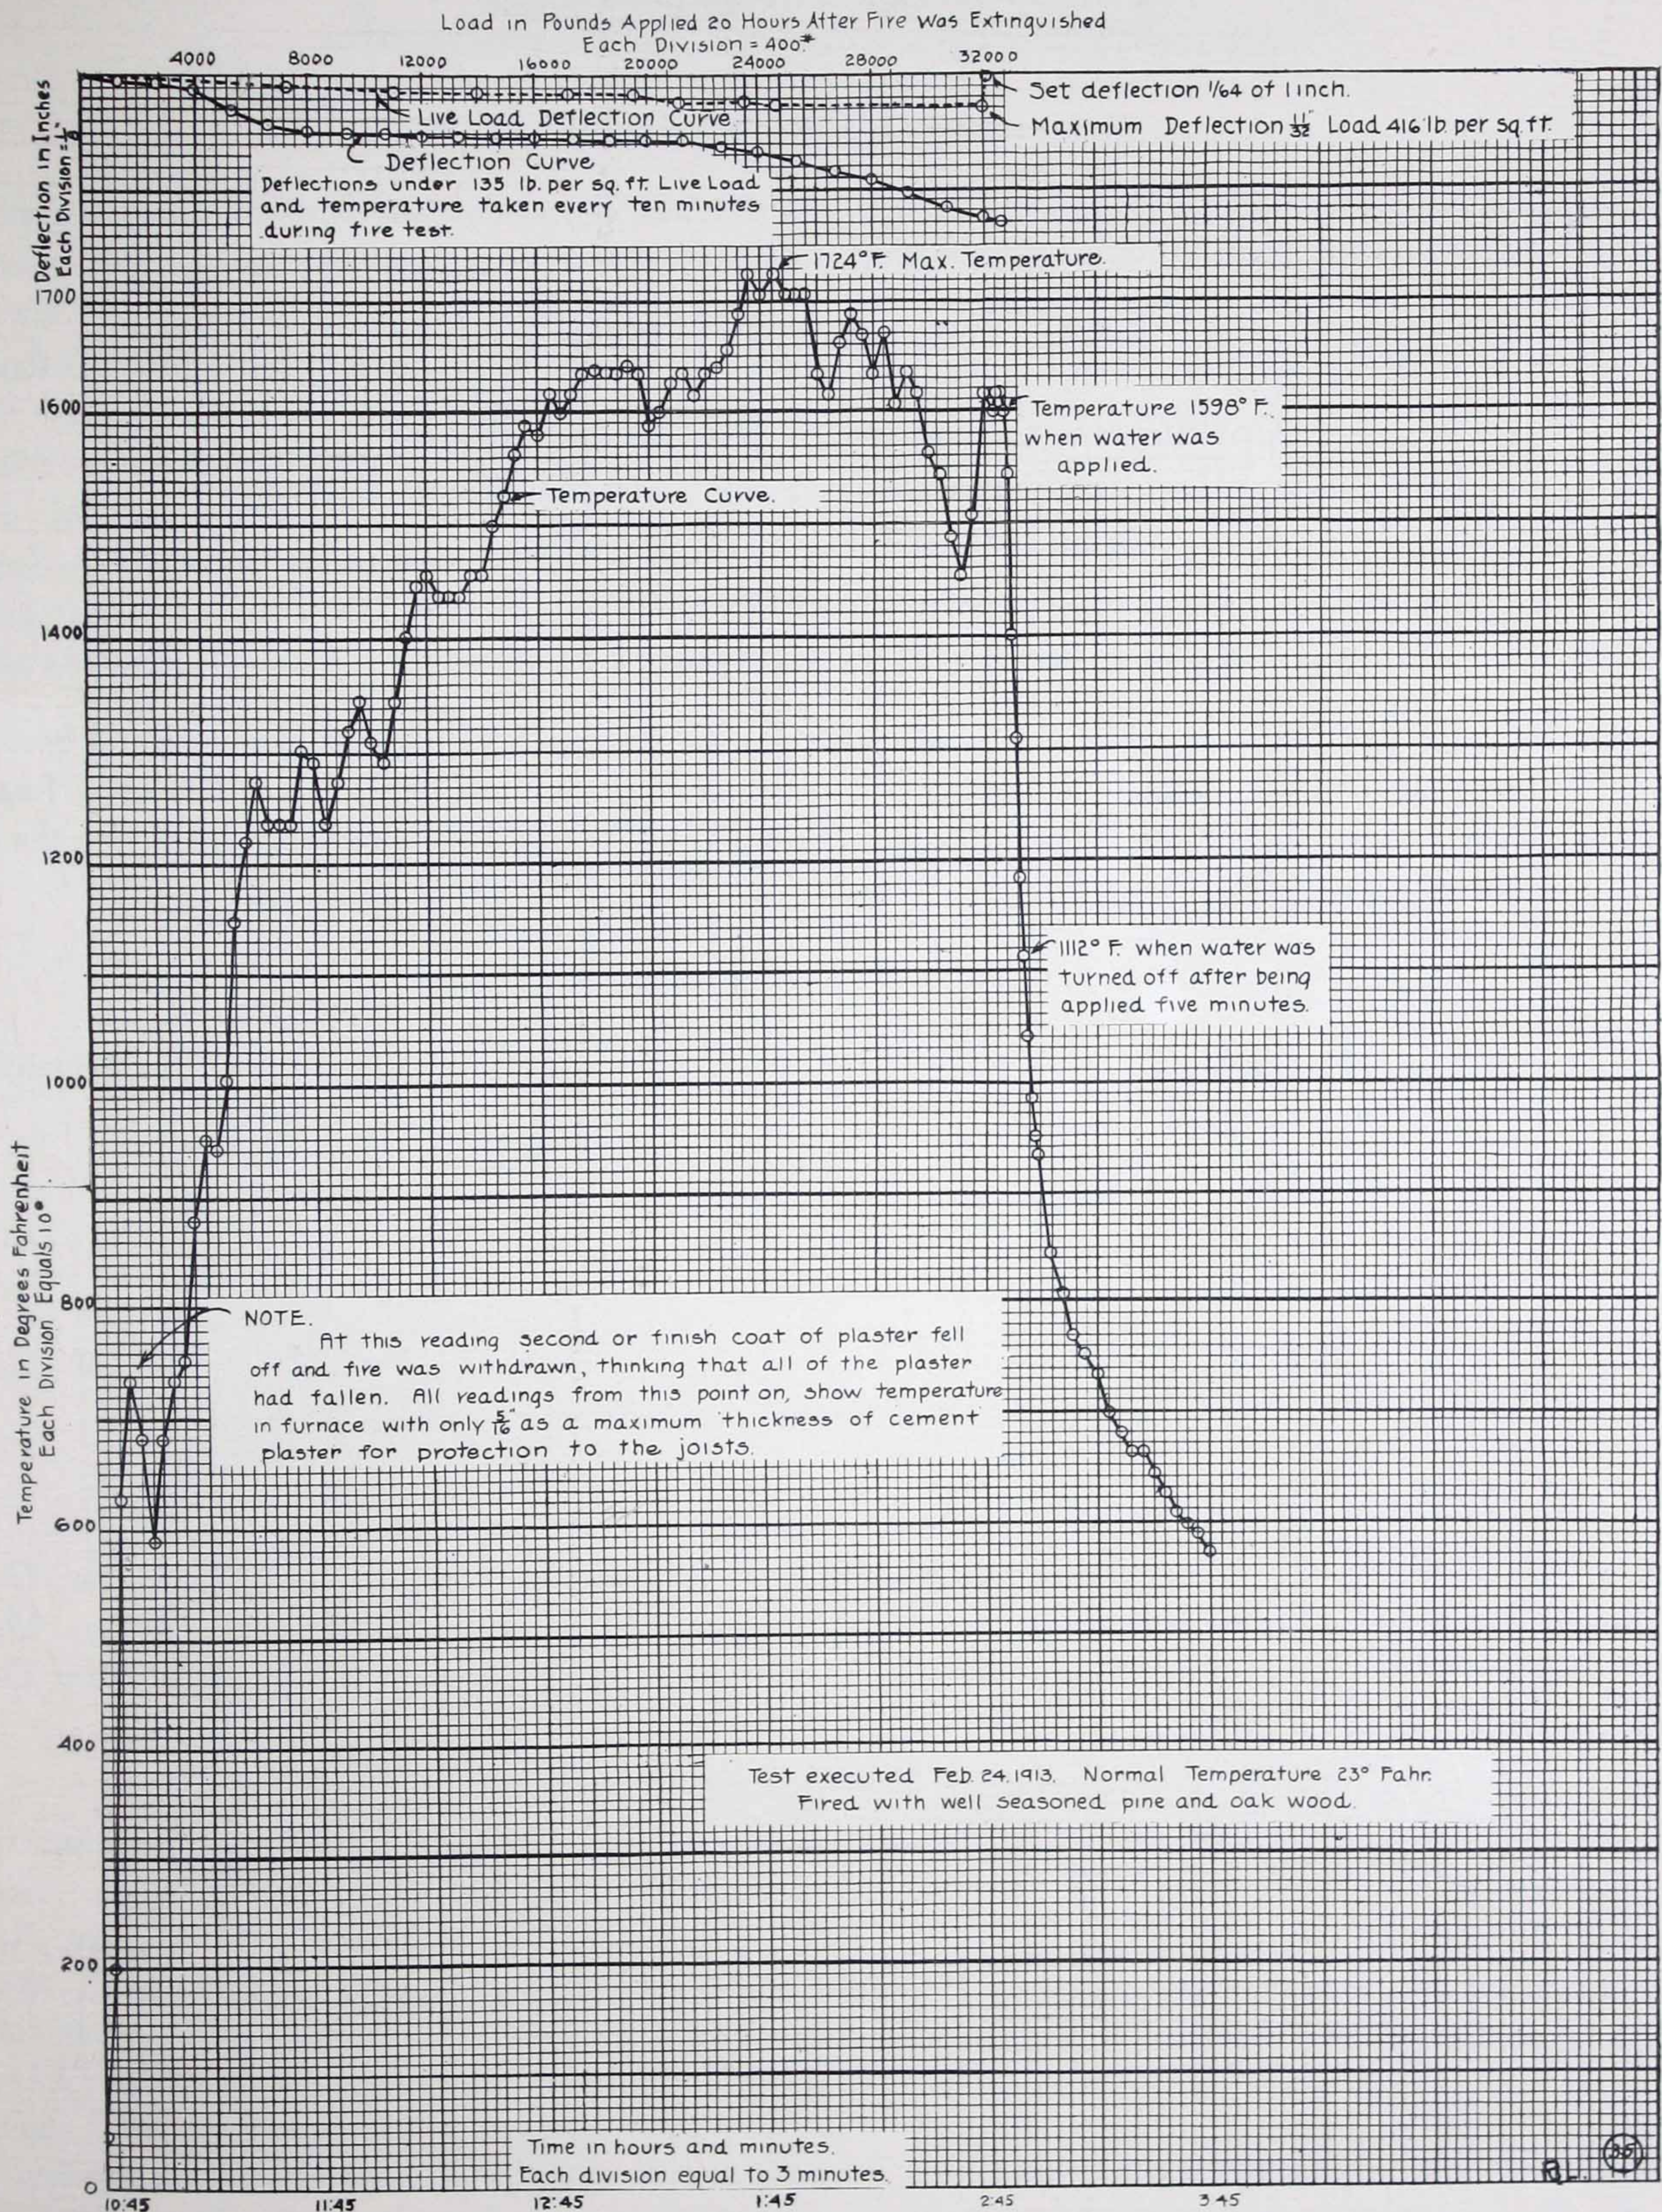
referring to temperature curves page 15 it will be noted that a drop in the temperature occurred at about 700 degrees and this was due to the first coat of plaster falling, causing the fire to be drawn. Careful reference to diagram of temperature curves will give information

TEMPERATURE AND DEFLECTION CURVES OF FIRE LOAD AND WATER TEST.

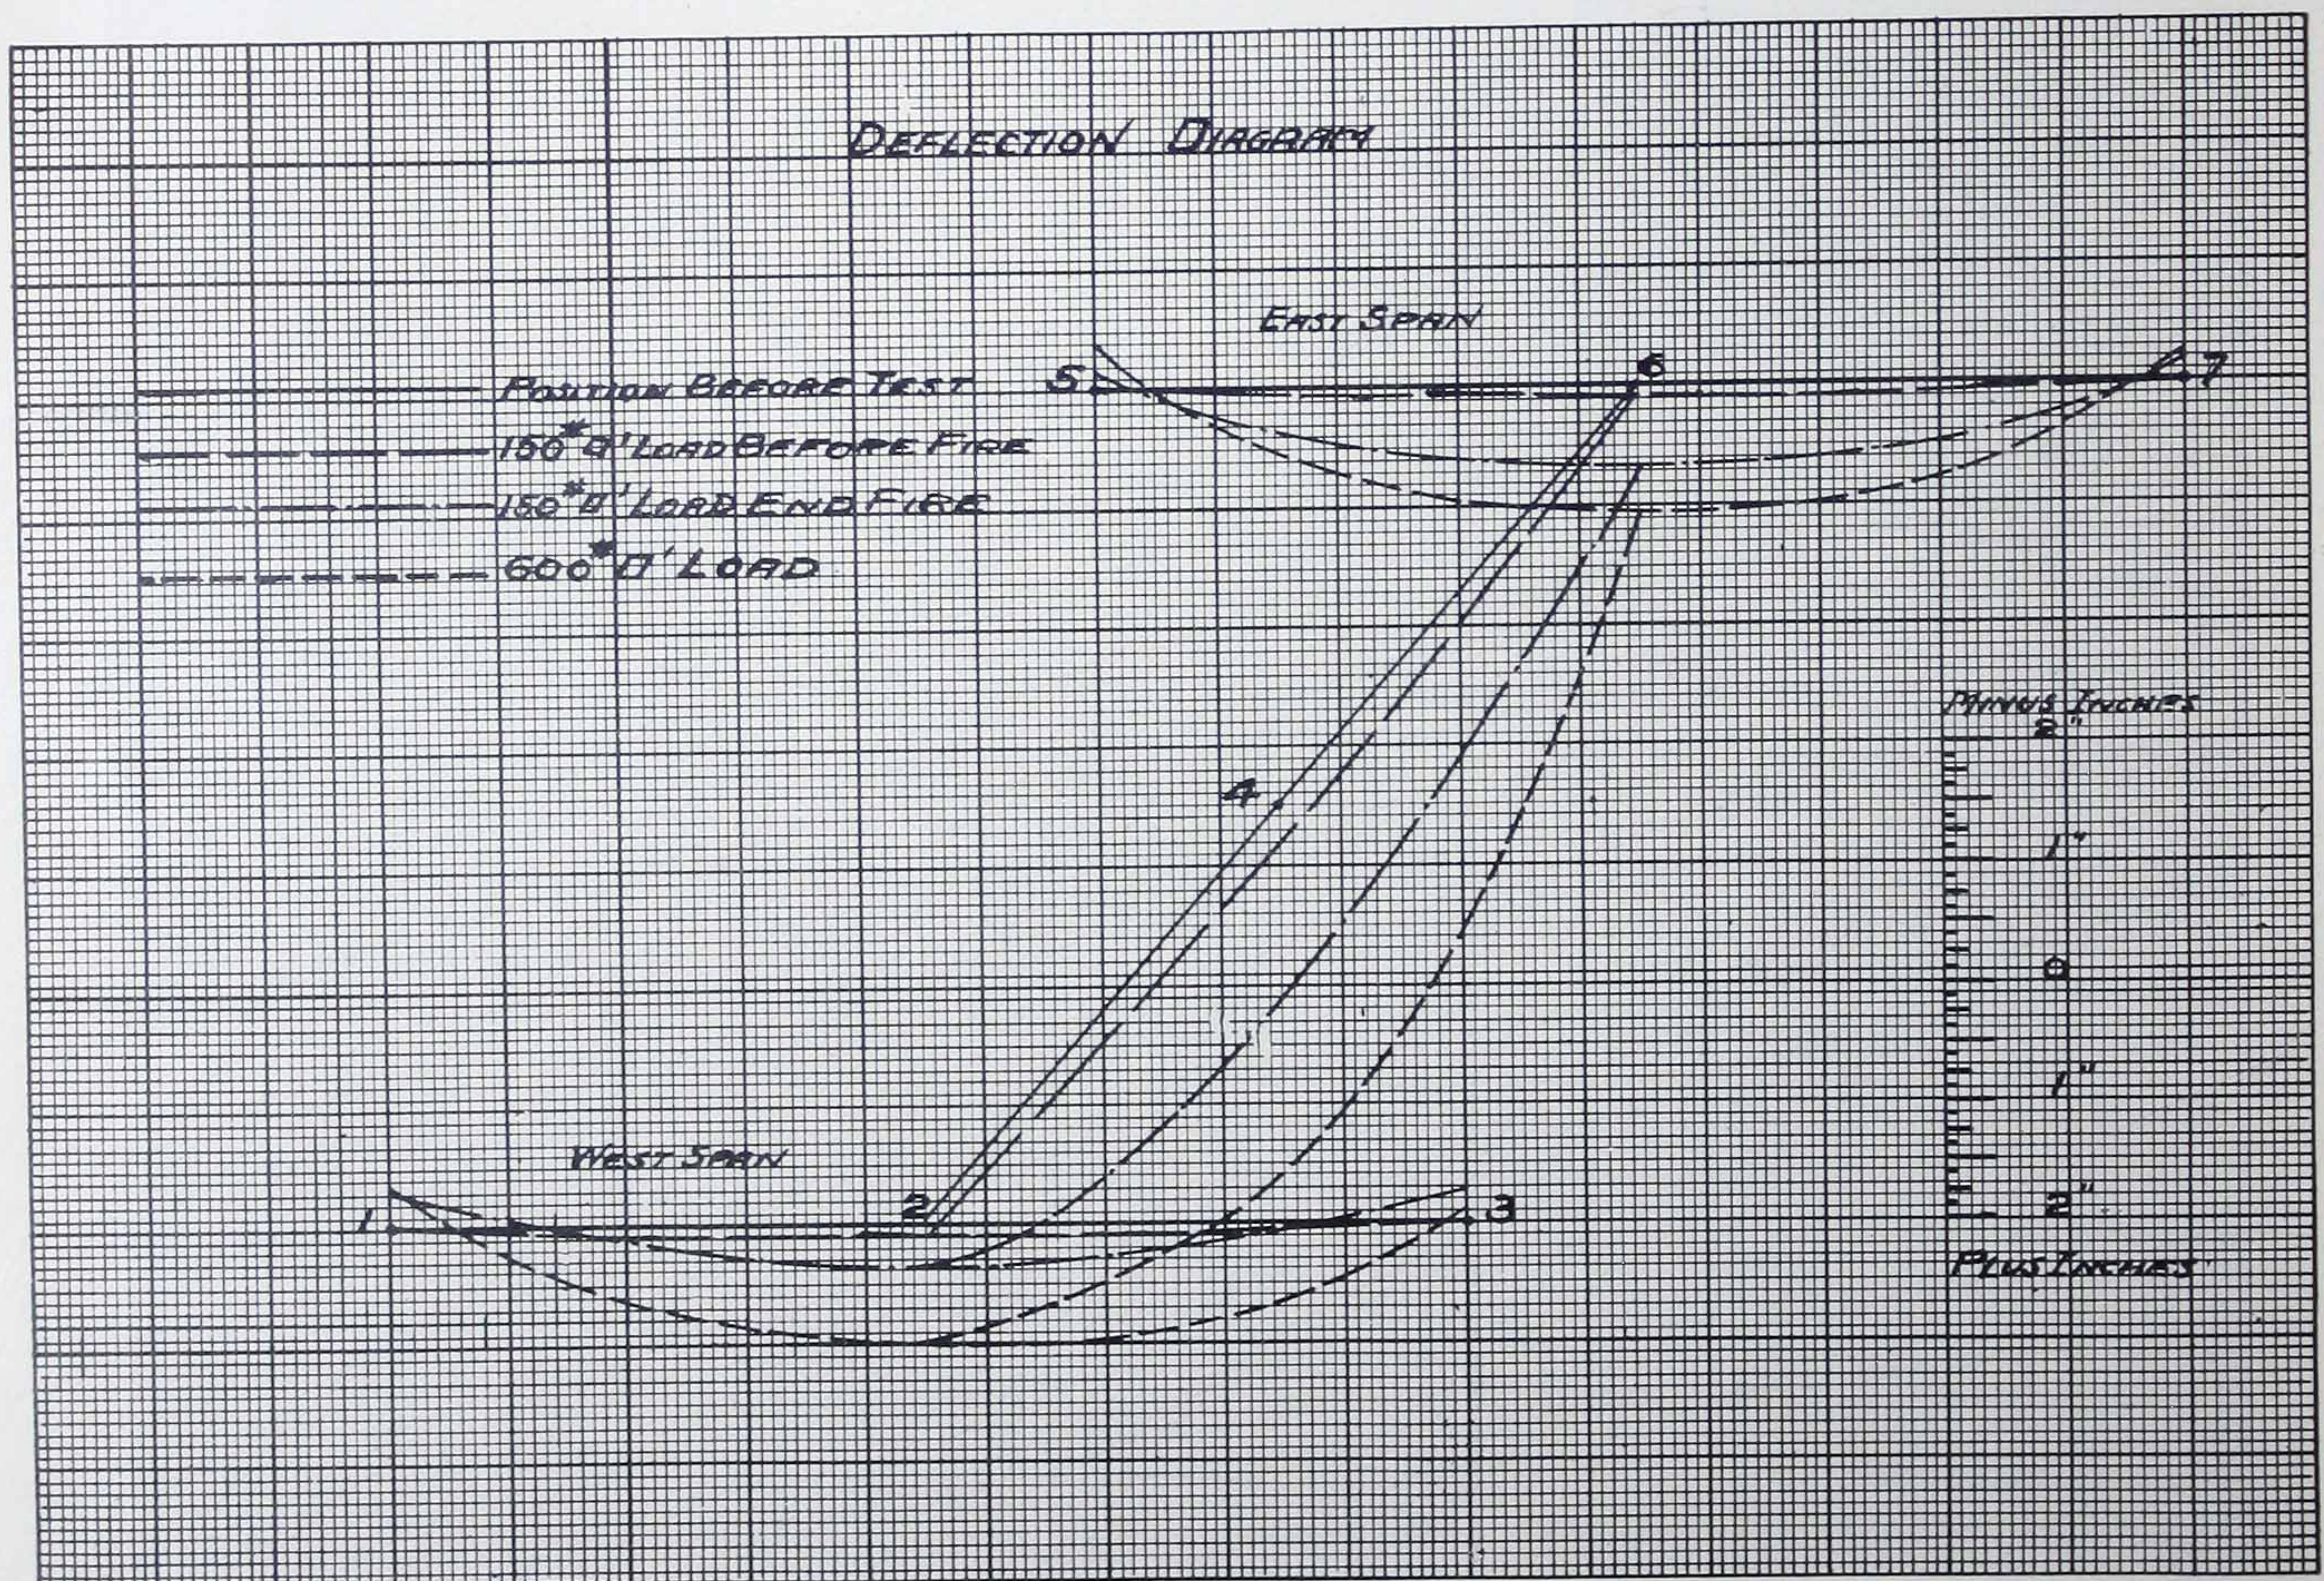
Deflection Chart.

The maximum corrected deflection of the east beam was  $\frac{55}{64}$  inch, of the west beam  $\frac{44}{64}$  inch, and of the center of the slab  $\frac{52}{64}$  inch. The log of deflection readings will be found on page 26.

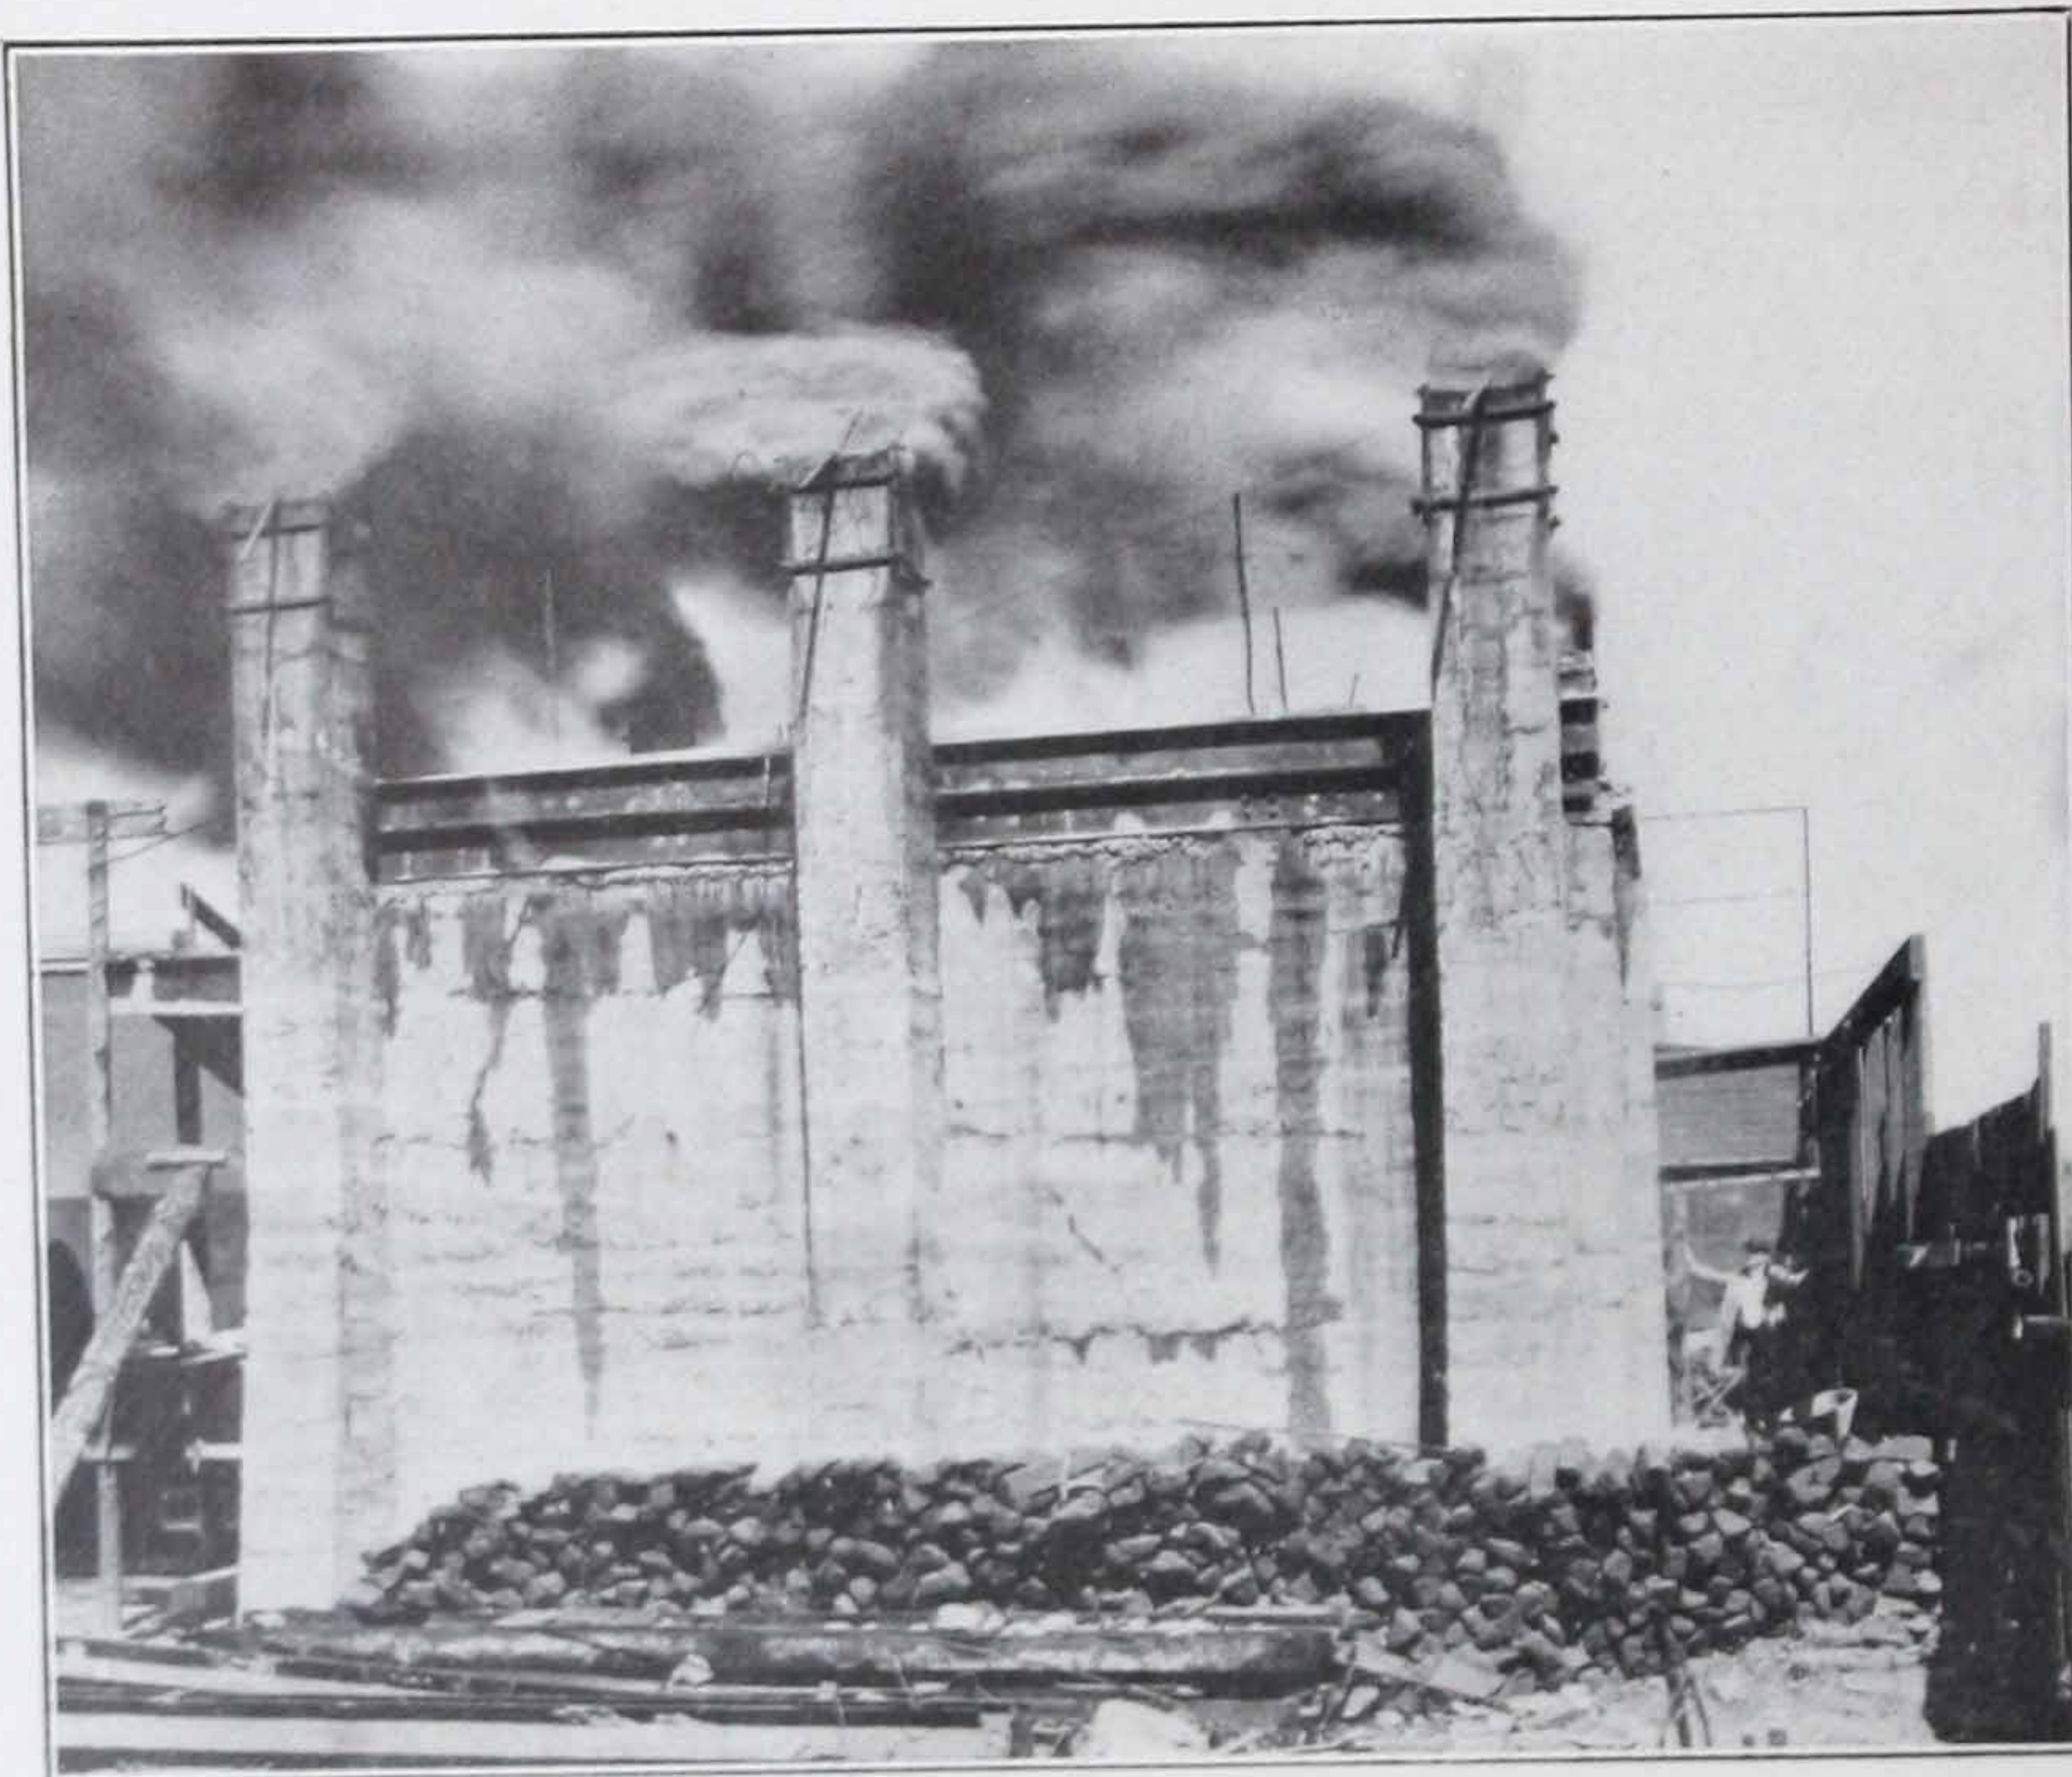
*After two hours and twenty-five minutes.* A slight flow of smoke was observed issuing through the crack along the top of the west beam. The amount escaping was small; in fact at times it was hardly perceptible. This continued to the end of the fire test.

Test House During the Fire.

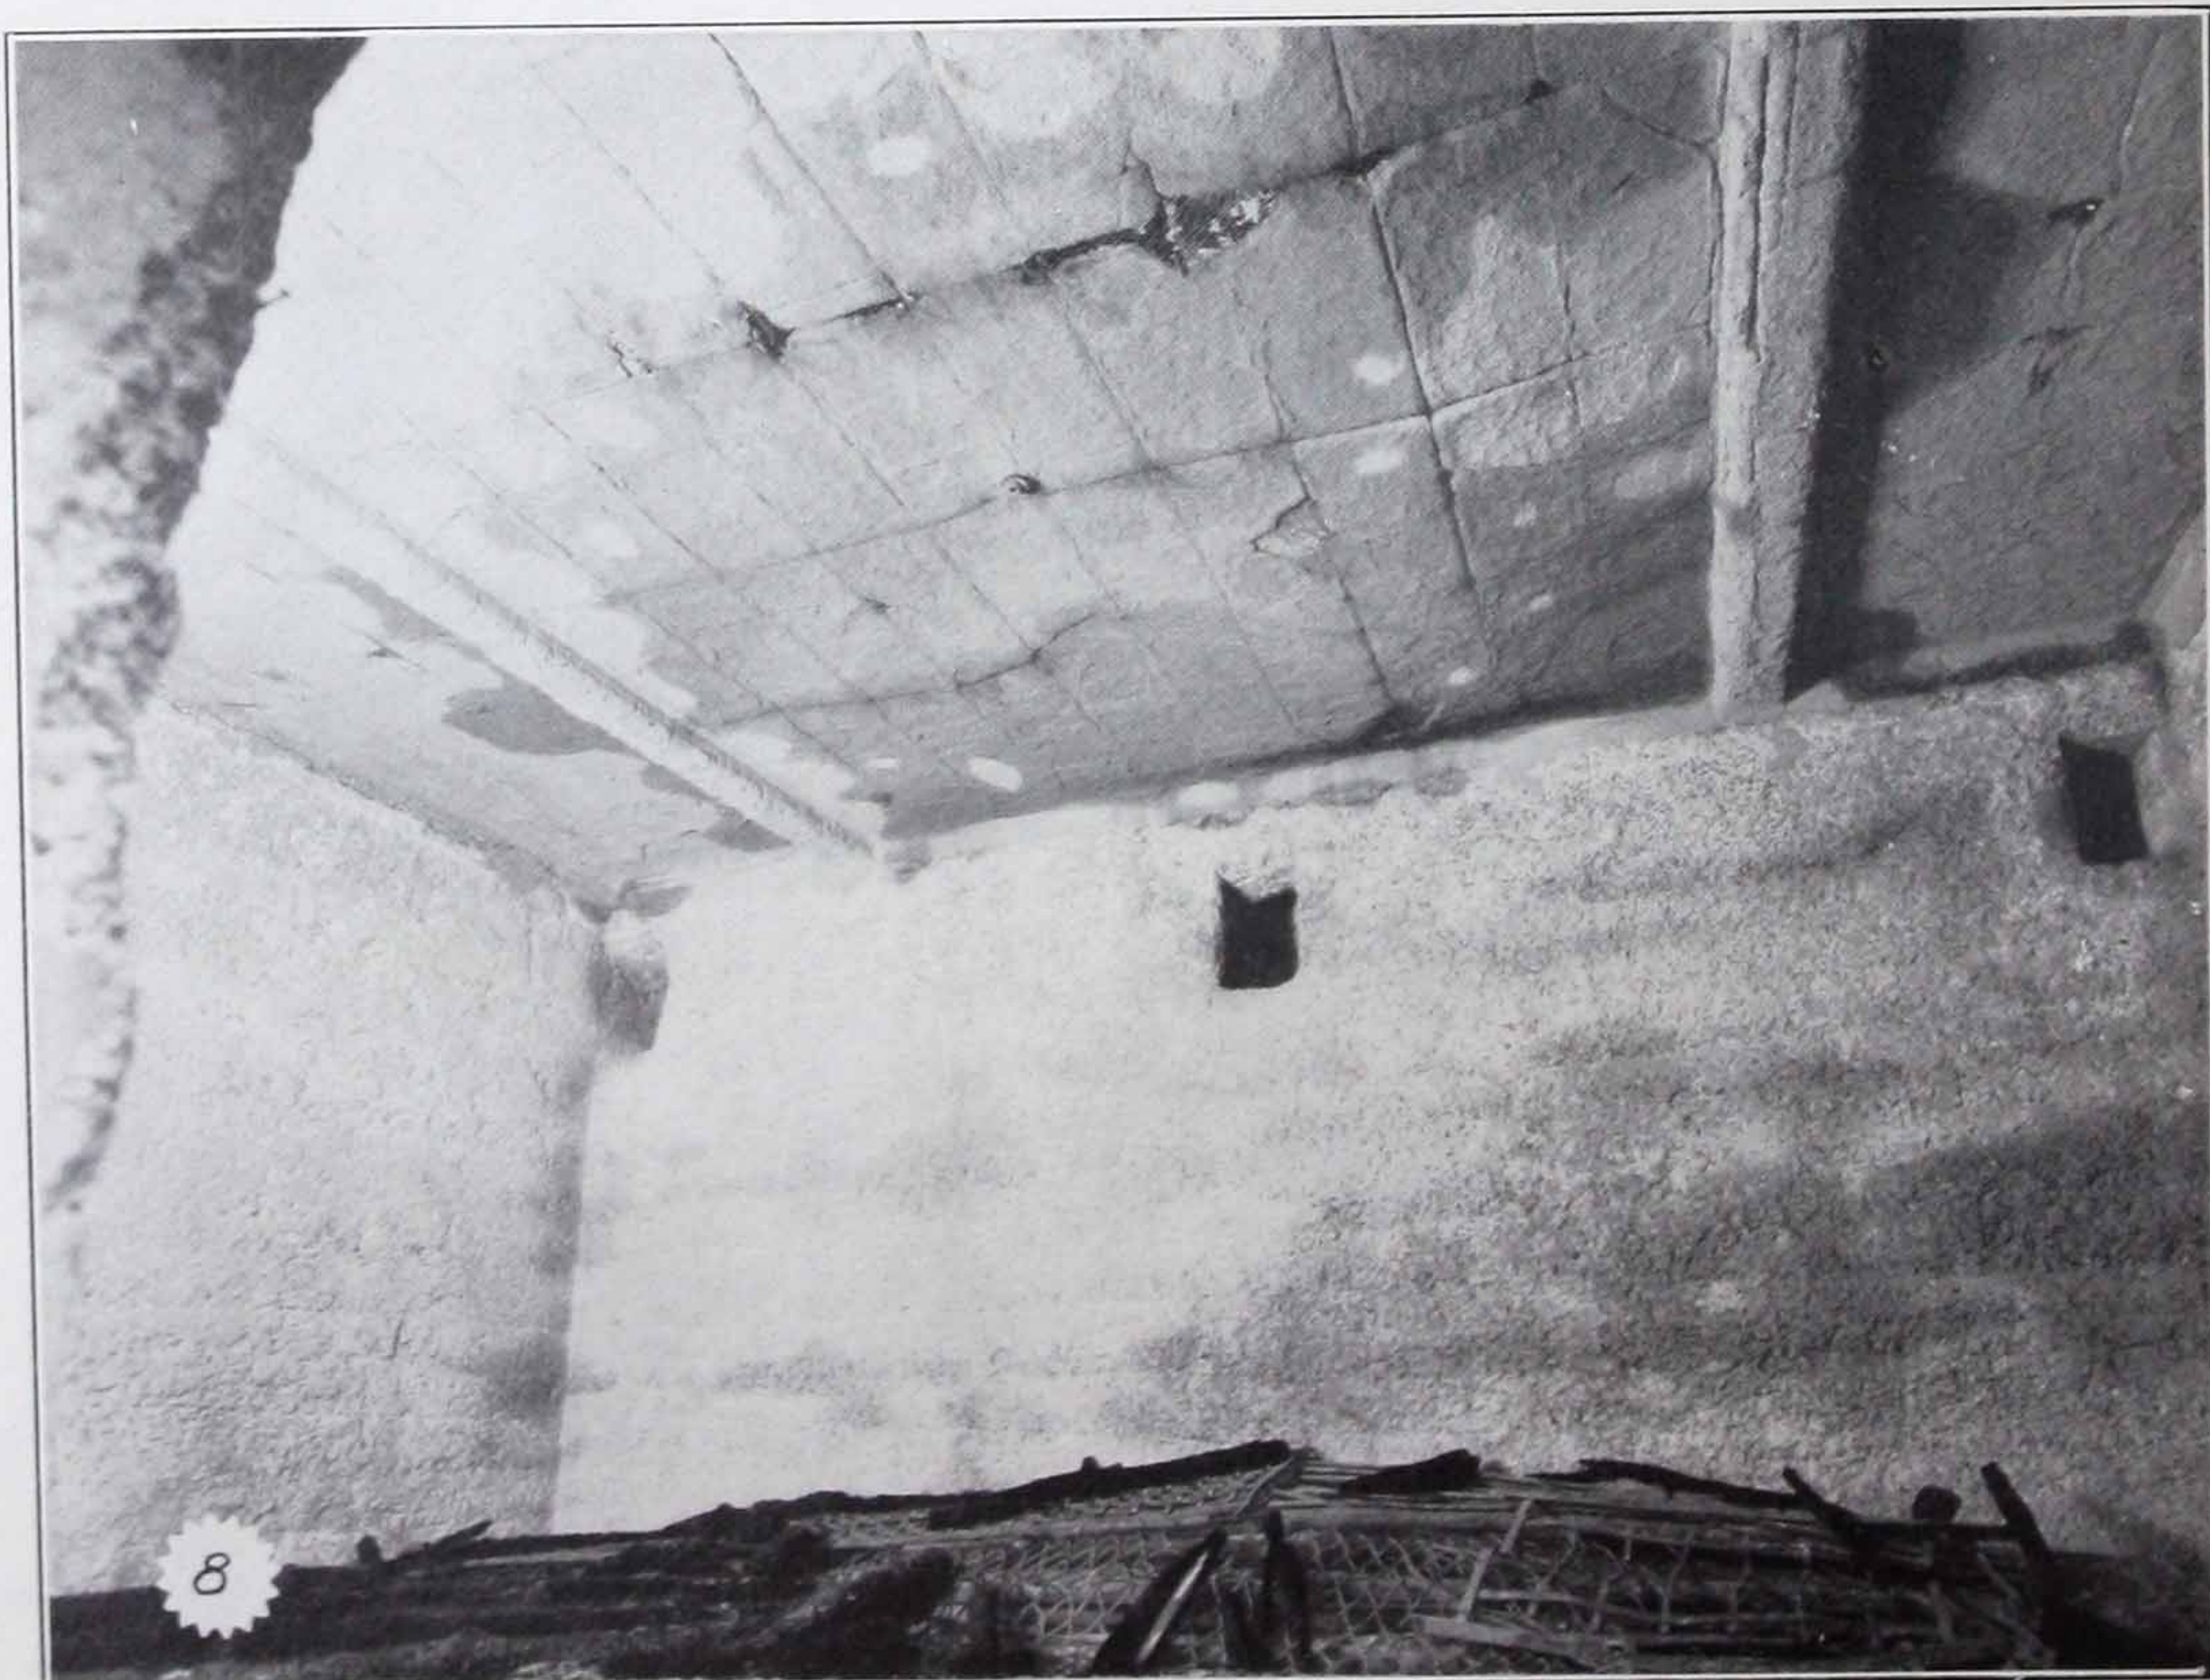
The application of water washed away the plaster coat to a depth of from  $\frac{3}{8}$  inch to  $\frac{1}{2}$  inch. Where cracks existed the plaster was furrowed out to varying depths; the general condition is clearly shown on page 26.

Several other very small areas were exposed. The bare lath after applying water formed about 2 per cent of the total area under test. Along the inner edge of the west beam the lath was exposed for a length of 5 feet to a width varying from 1 inch to  $1\frac{1}{2}$  inches.

Under Side of Floor After the Fire and Water Test.

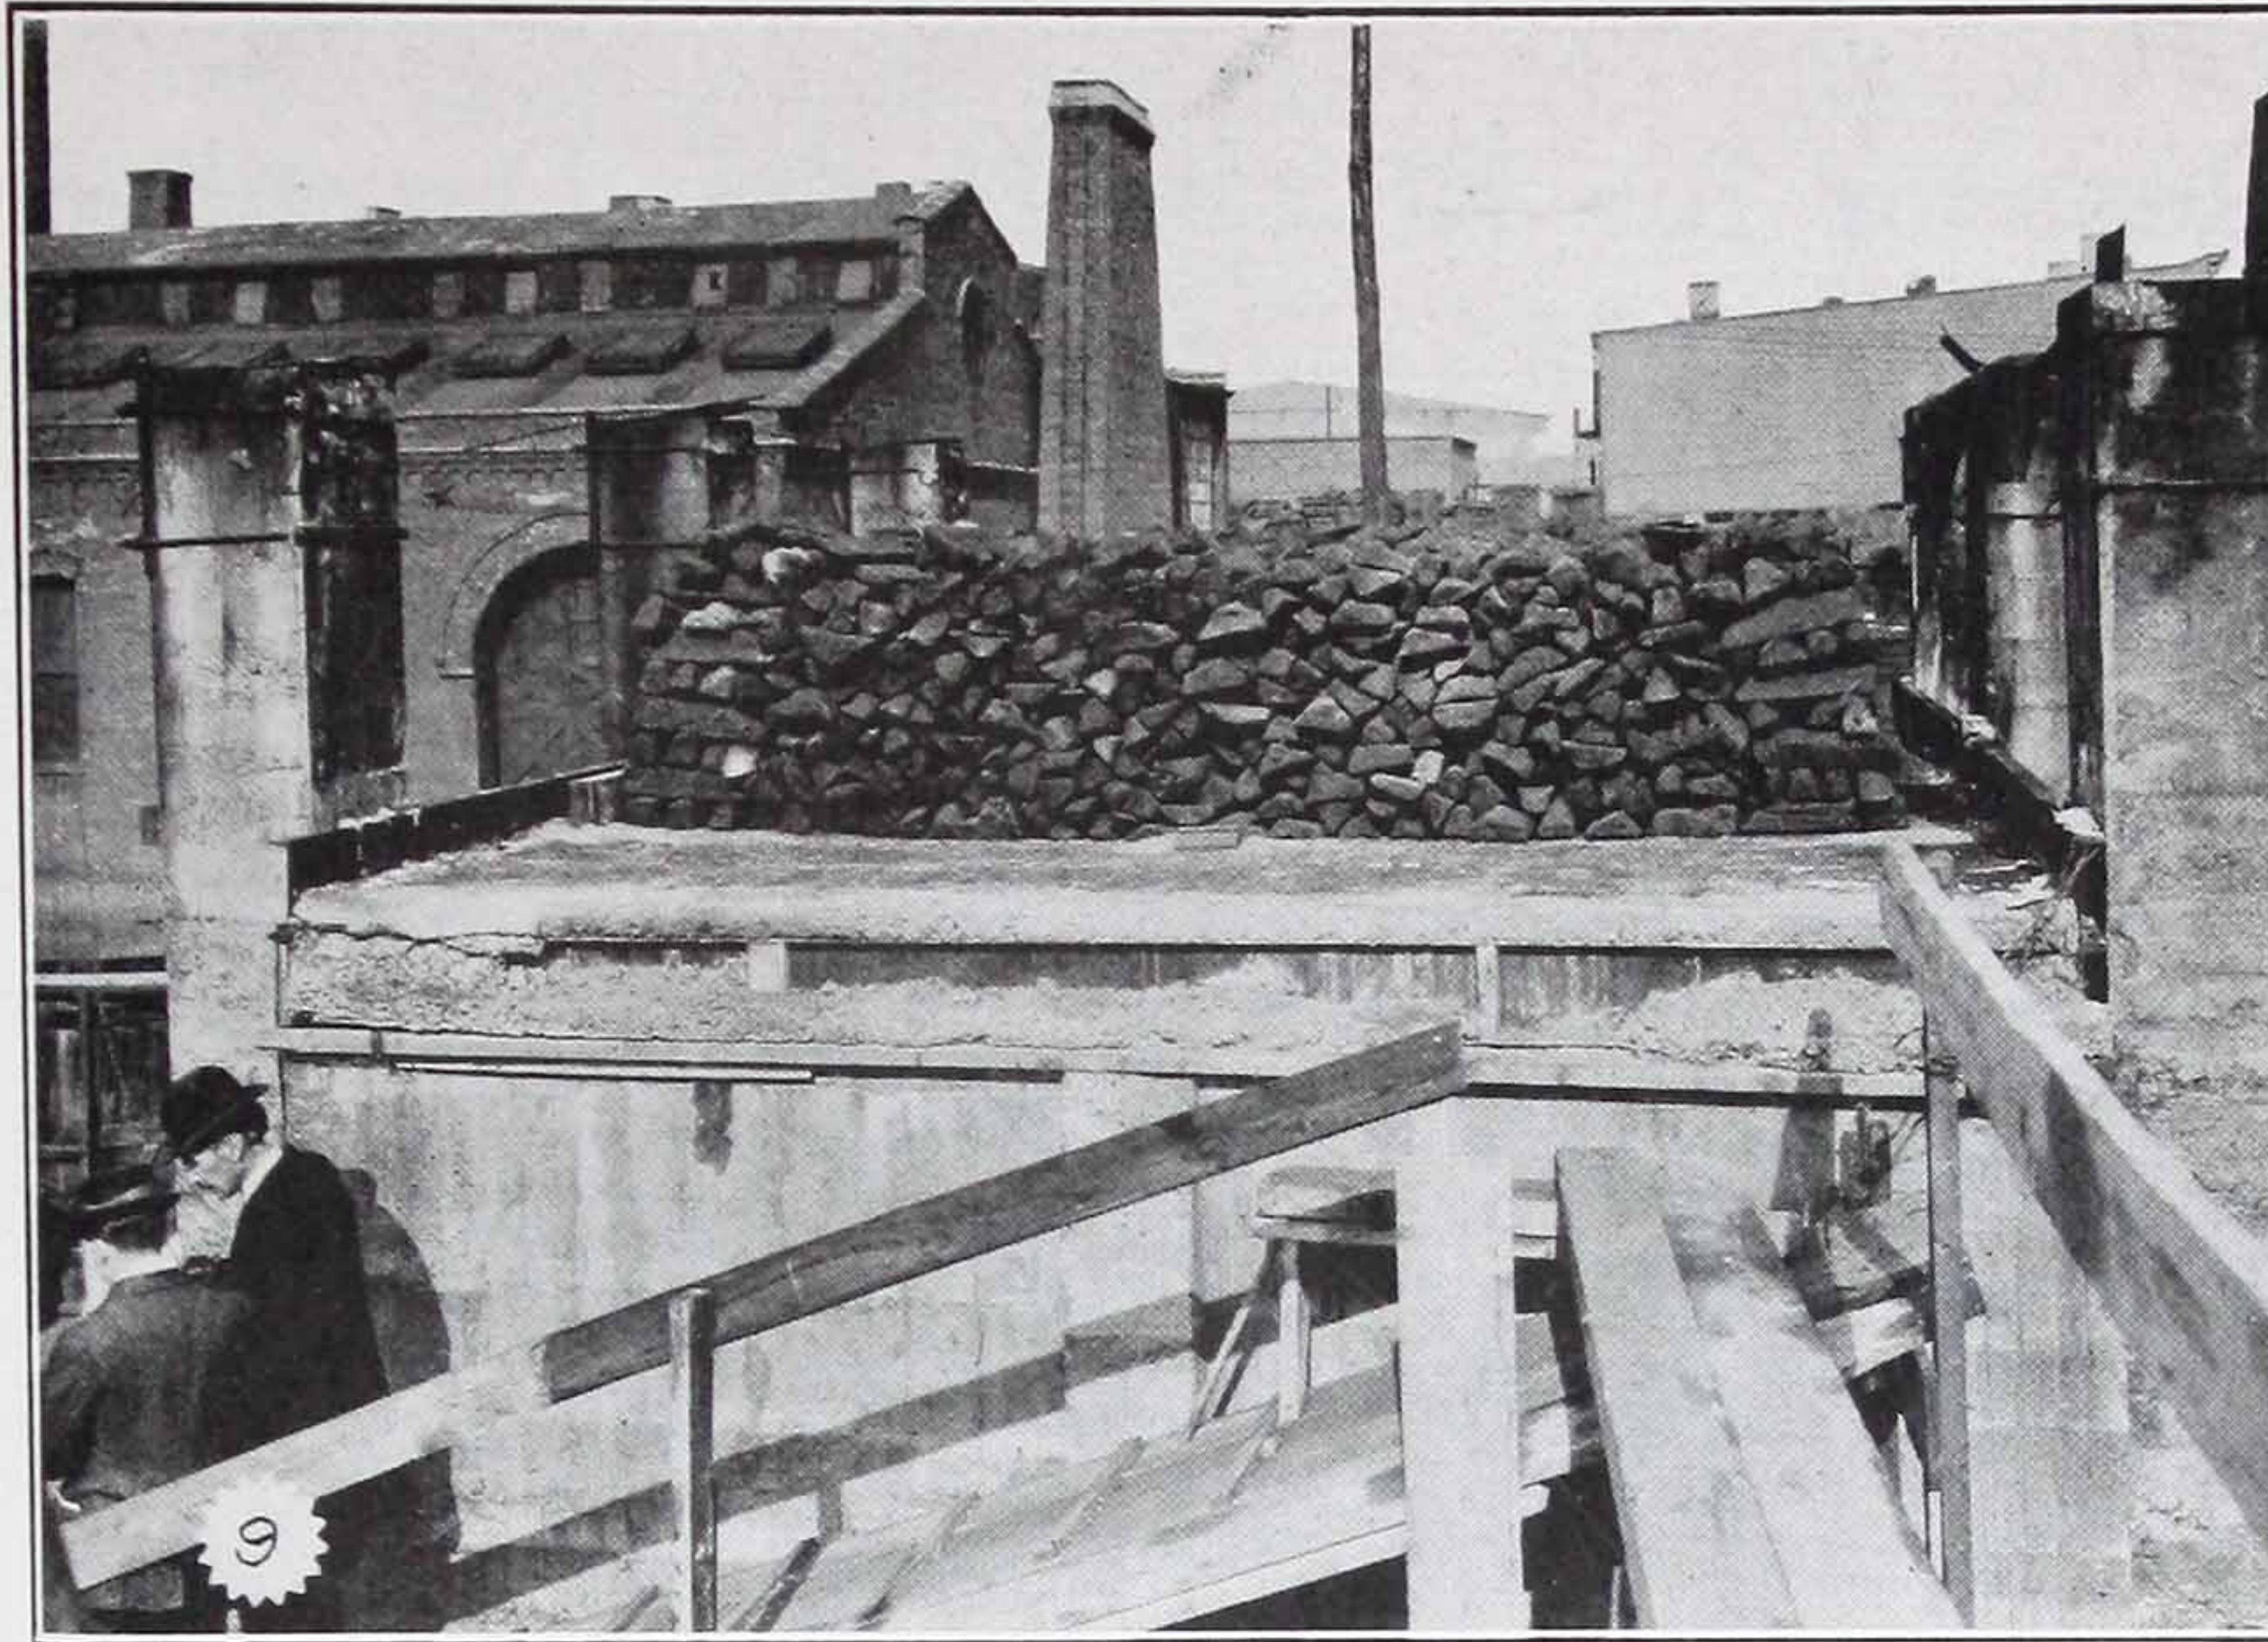
The application of the load of 600 pounds per square foot (see page 27), caused the beams and floor slabs to deflect as follows: West beam  $1\frac{19}{64}$  inches, east beam  $1\frac{24}{64}$  inches, middle of floor slab  $1\frac{49}{64}$  inches. Upon removal of load the permanent deformation in the west beam was  $\frac{42}{64}$  inch, in the east beam  $\frac{44}{64}$  inch, and in the center of the floor slab  $\frac{45}{64}$  inch. The day following the loading test the cinder

Load of 600 lbs. per Square Foot Applied to Floor on the Day Following the Fire and Water Test.
